CONTINUING ELIGIBILITY INSPECTION (CEI) REPORT
FOR FLOOD CONTROL PROJECTS

1. Project Name: Iao Stream FCP for FY03

2. Date of Inspection: October 28, 2002

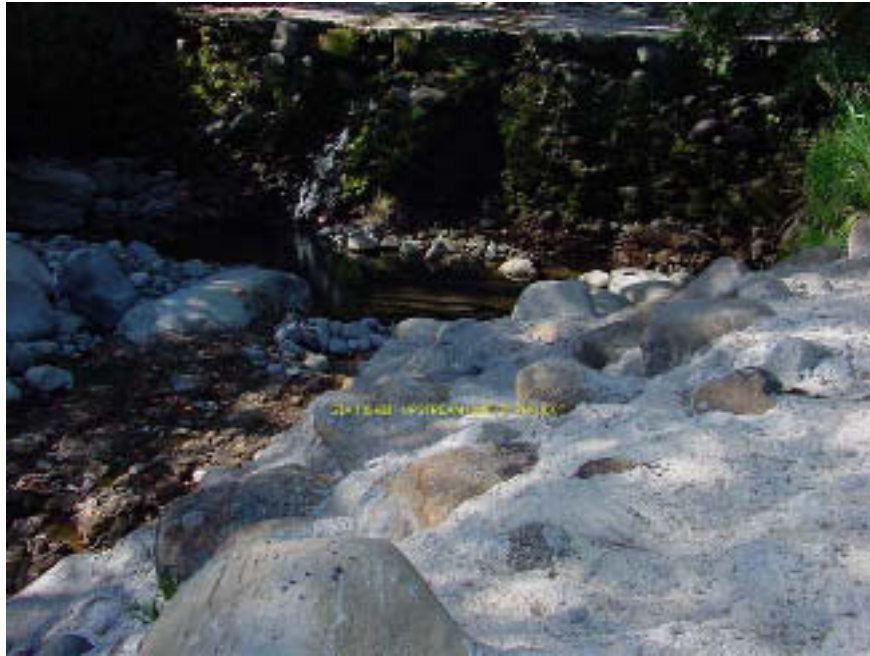
a. Overview of the grouted rock slope protection on the Left Bank (LB) at Sta. 135+00 upstream of the debris basin, at Levee I.

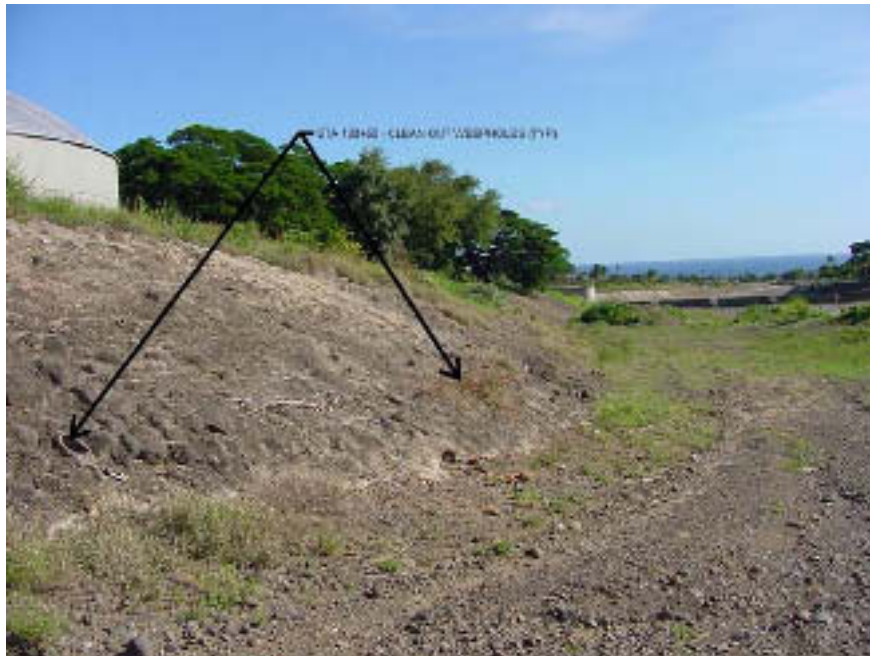
| Station | Location | Description |
|---|---|---|
| 130+50 | Levee H, LB | Clean weep holes of vegetation (typical). |

b. Sta. 130+50, Left Bank, (LB), clean weep holes as required.

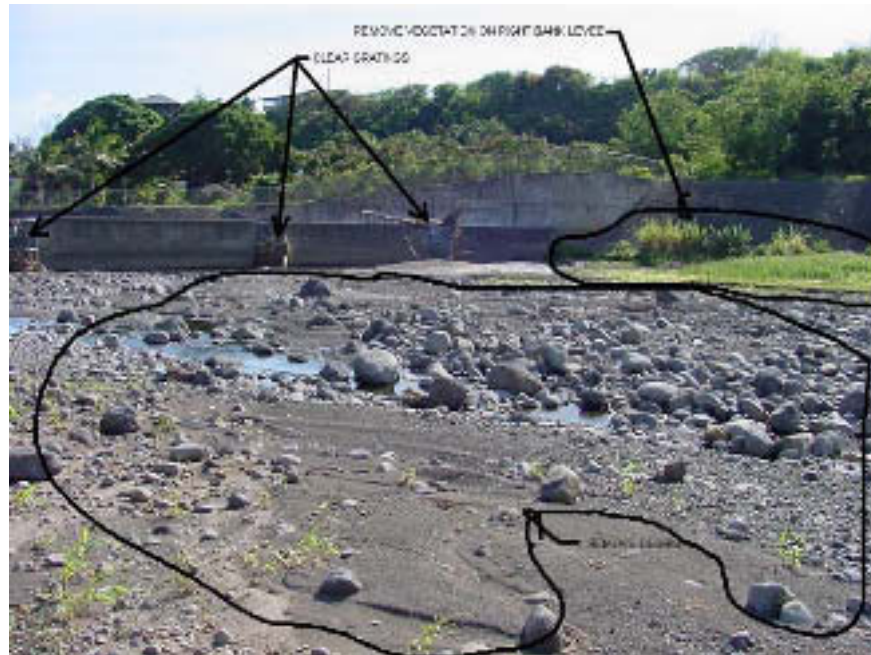
| Station | Location | Description |
|---|---|---|
| 127+00 | Levee H, debris basin | Remove debris, clear gratings, and remove vegetation on RB levee. |

c. Sta. 127+00, remove debris. Clear gratings. Remove vegetation on right bank levee.

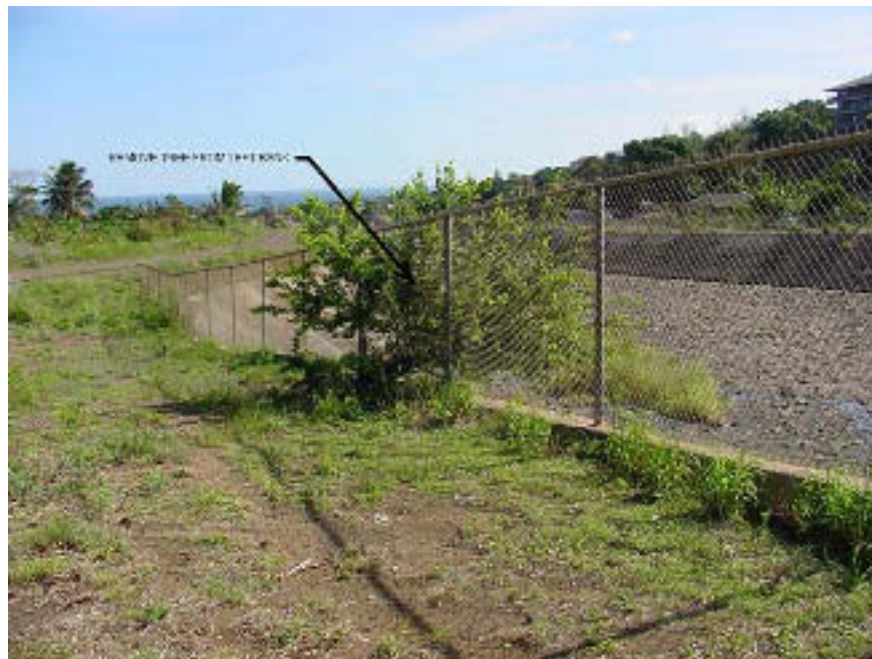
| Station | Location | Description |
|---|---|---|
| 127+00 | Levee H, LB fence line | Remove tree from fence. |

d. Sta. 127+00, Left Bank, (LB), remove tree from fence line.

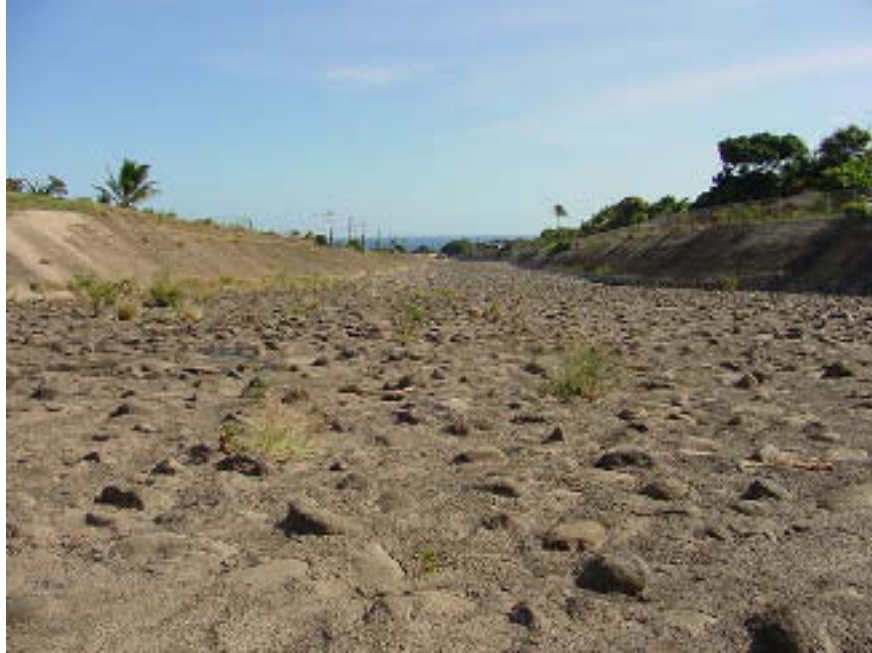
| Station | Location | Description |
|---|---|---|
| 125+00 | Levee H, channel | Remove vegetation. |

e. Sta. 125+00, overview - remove vegetation along channel.

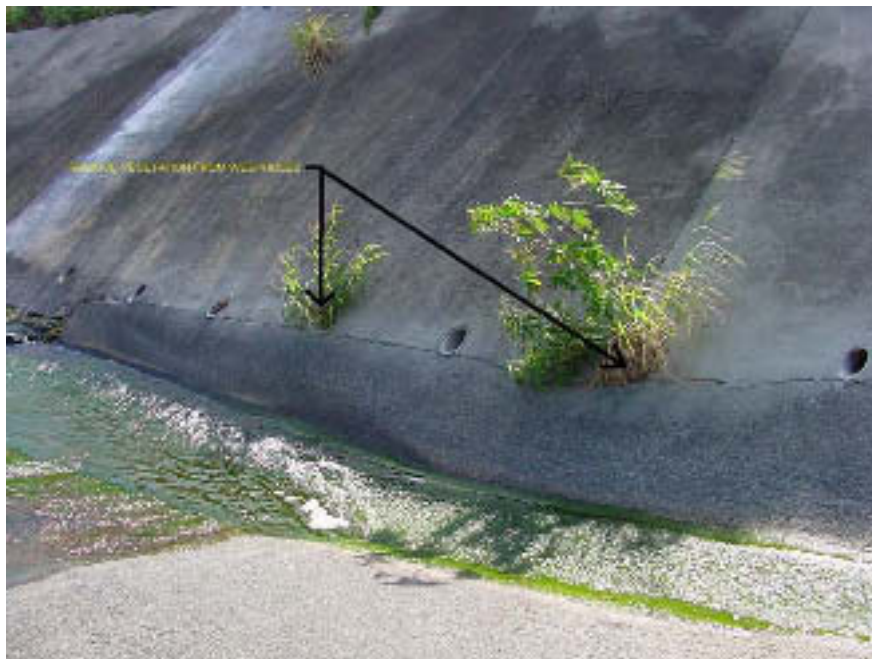
| Station | Location | Description |
|---|---|---|
| 119+00 | Levee H, RB drop apron #1 | Remove vegetation from weep holes (typical). |

f. Sta. 119+00, RB, drop apron #1 - remove vegetation from weepholes (typical).

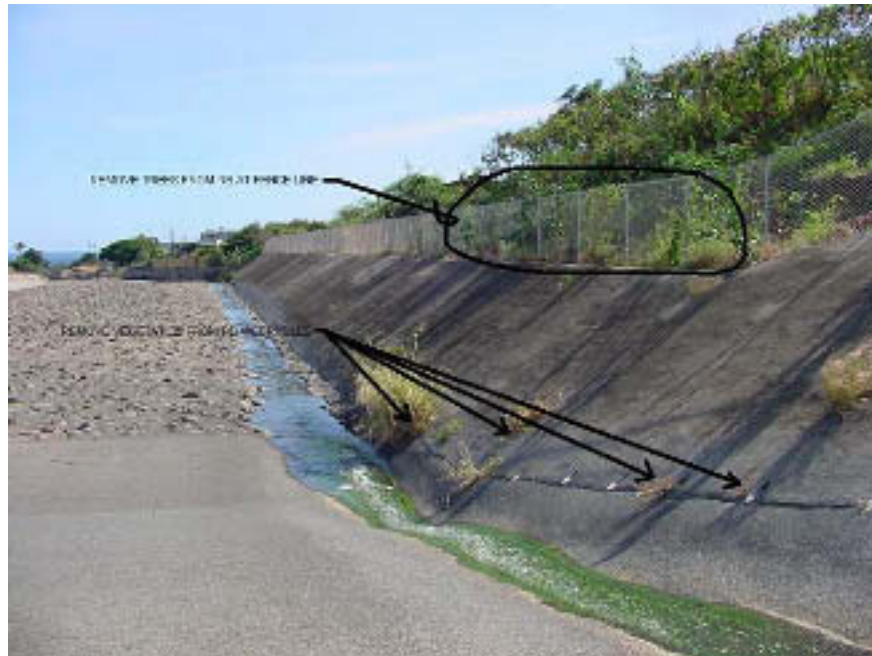
| Station | Location | Description |
|---|---|---|
| 114+50 | Levee H, RB drop apron #2 | Remove vegetation from weep holes and trees from top of fence. |

g. Sta. 114+50, RB, drop apron #2 - remove vegetation and trees from top of fence.

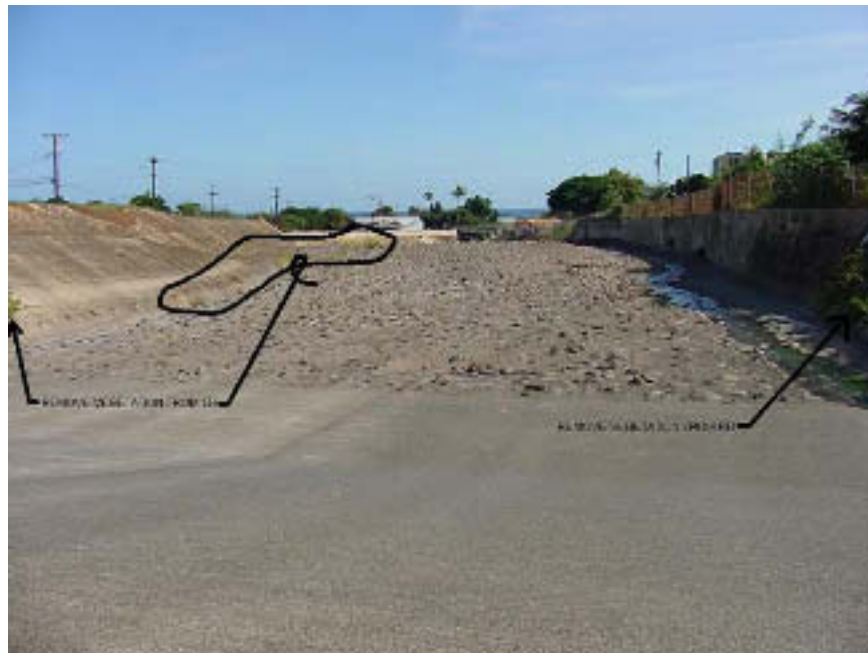
| Station | Location | Description |
|---|---|---|
| 109+75 | Levee H, drop apron #3 | Remove vegetation on LB and RB. |

h. Sta. 109+75, drop apron #3 - remove vegetation on left and right bank.

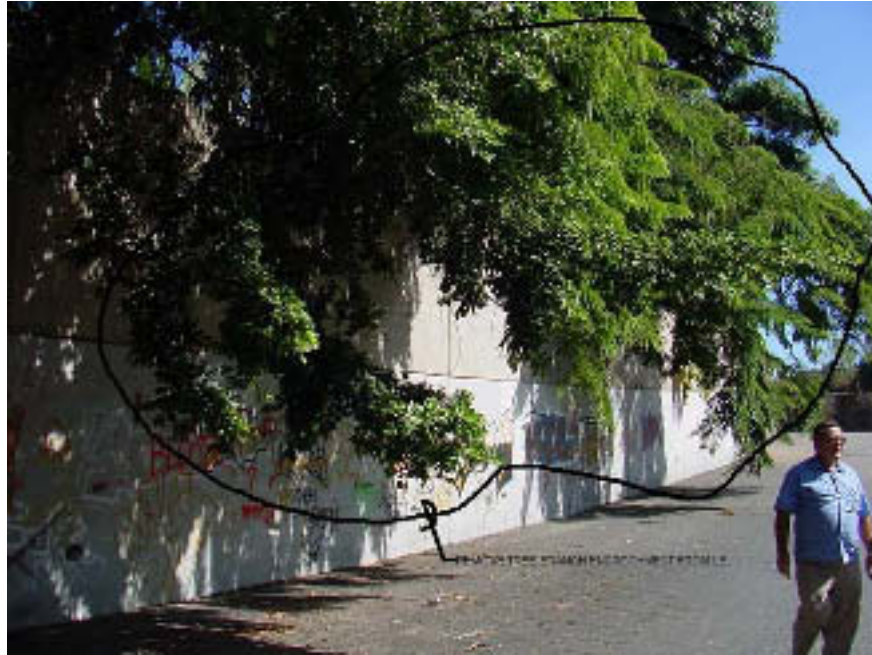
| Station | Location | Description |
|---|---|---|
| 99+50 | LB, downstream Market Street Bridge | Remove tree branch encroachment from top of LB. |

i. Sta. 99+50, Left Bank (LB), remove tree/branch encroachment onto channel *.

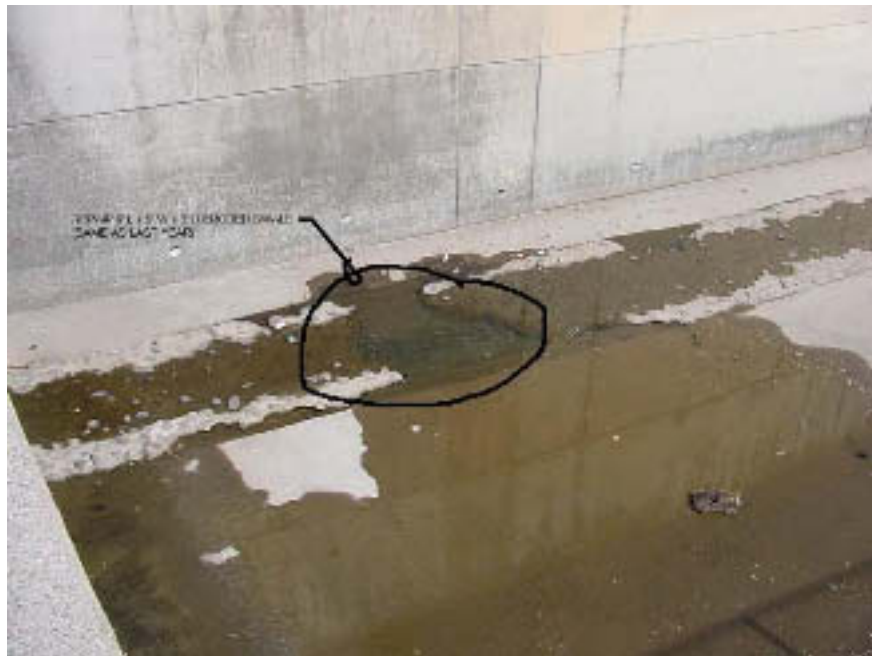
| Station | Location | Description |
|---|---|---|
| 96+75 | LB, downstream Market Street Bridge after first drop structure | Repair eroded concrete hole (6'L x 5'W x 3'D) in swale. Same comment from FY02 report. |

j. Sta. 96+75, LB, side of invert, eroded concrete not yet repaired from FY02 inspection *.

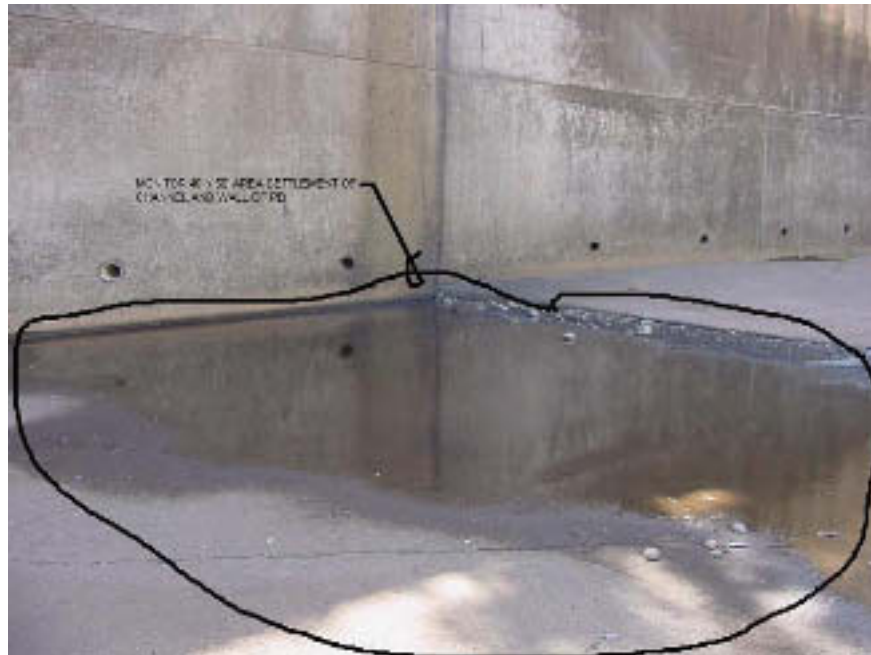
| Station | Location | Description |
|---|---|---|
| 93+25 | RB, 350' downstream of first drop structure from Market Street Bridge | Sidewall and channel invert are settling. Need to monitor 40'x50' area. Remove tree and debris at top of RB wall for further inspection. Beware of geese and dogs at top of RB. |

k. Sta. 93+25, RB, sidewall and invert settling. (Location is about 350' downstream of drop structure.) Repair invert.

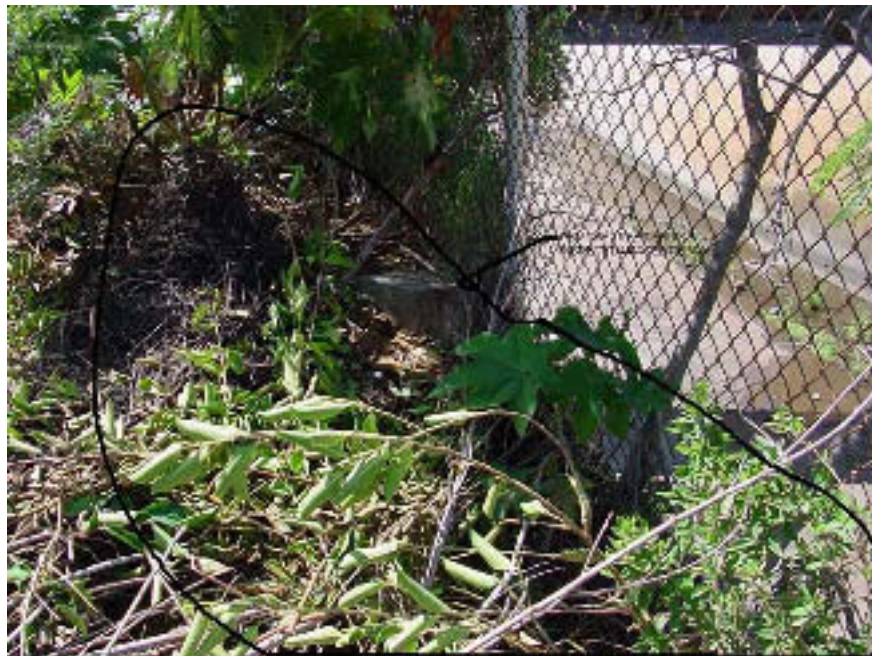
l. Sta. 93+25, RB, remove tree and debris at top of RB wall to inspect damaged/settling portion of channel sidewall.

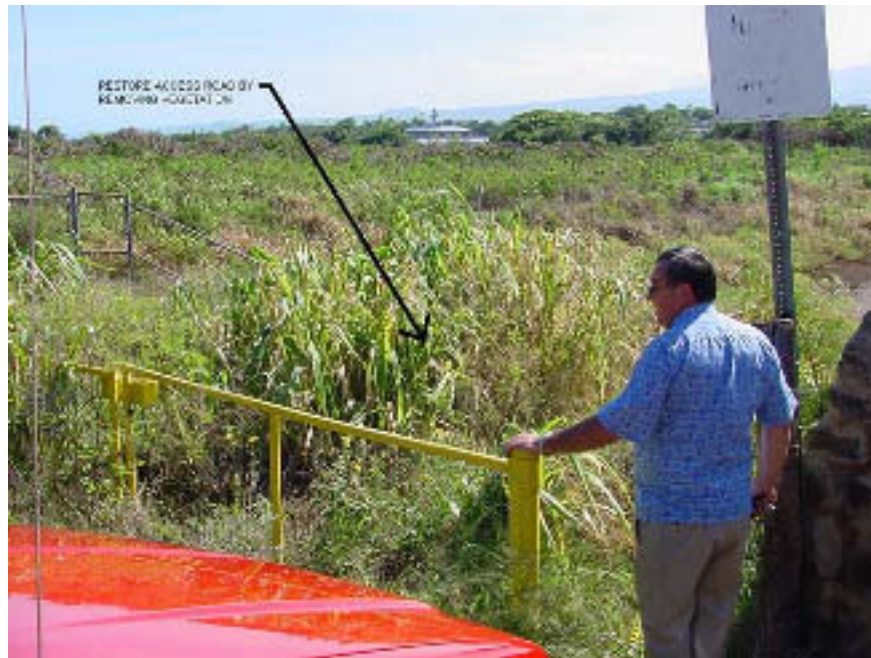
| Station | Location | Description |
|---|---|---|
| 85+00 | Levee G, access road | Cut vegetation and restore viable path to access road. |

m. Sta. 85+00, restore access road to channel by cutting vegetation.

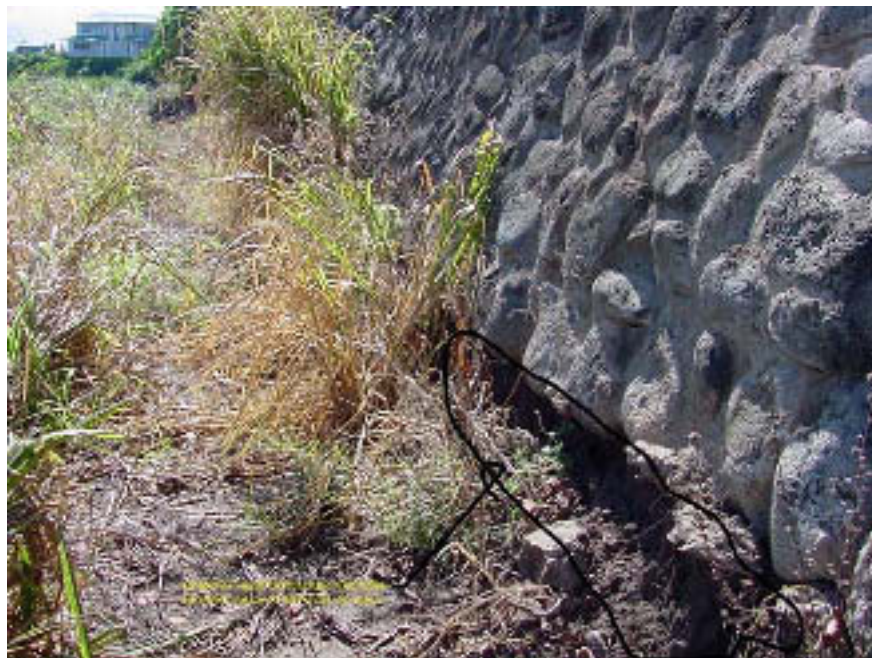
| Station | Location | Description |
|---|---|---|
| 85+00 | Levee G | Fill in eroded bottom wall of levee and remove vegetation in vicinity. |

n. Sta. 85+00, remove vegetation and fill in eroded bottom wall.

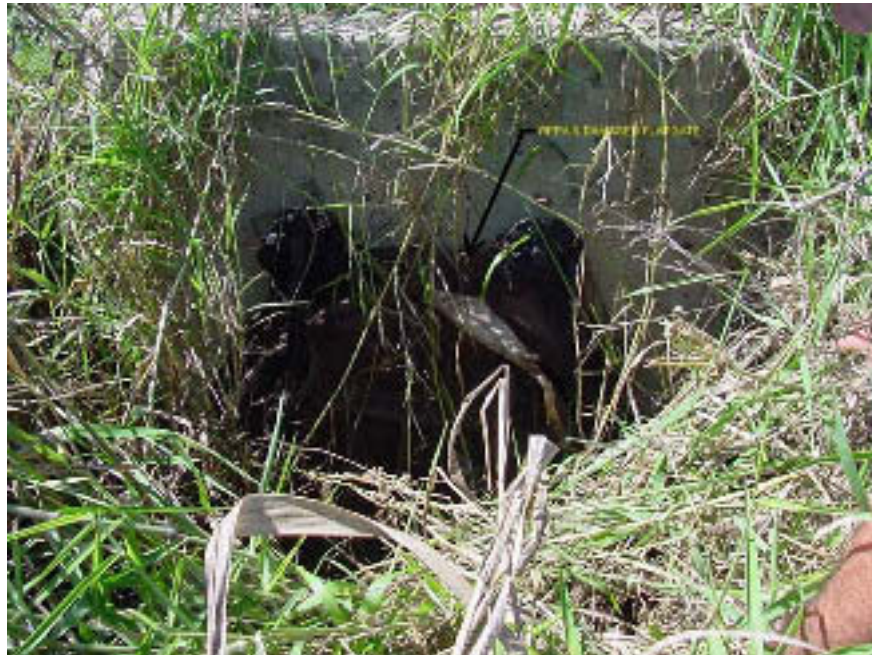
| Station | Location | Description |
|---|---|---|
| 85+00 | Levee G | Replace damaged flapgate. |

- o. Sta. 85+00, replace damaged flapgate.

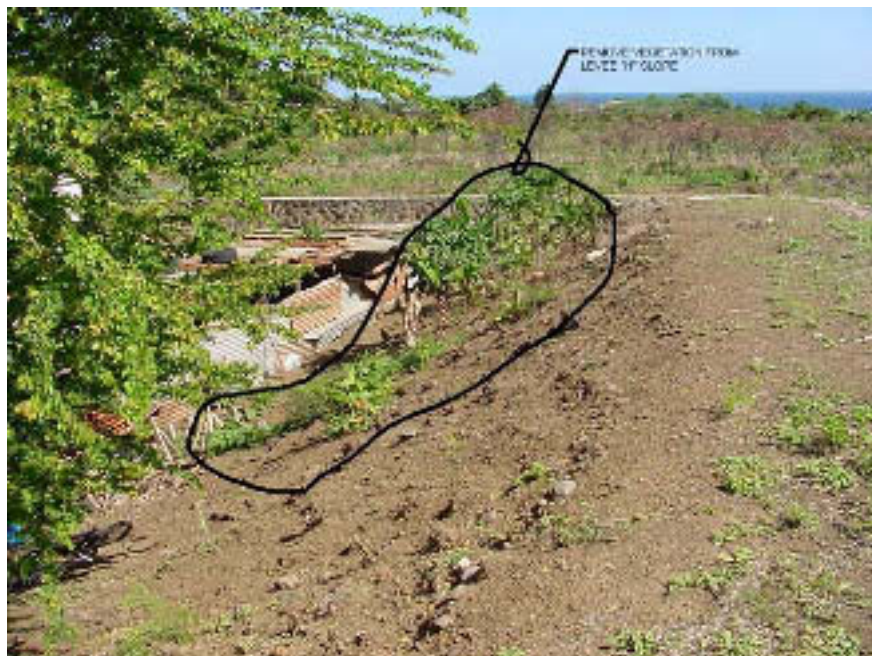
| Station | Location | Description |
|---|---|---|
| 87+50 | Levee G | Remove vegetation material. Beware of dogs. |

- p. Sta. 87+50, remove encroachments (vegetation and fencing) and restore levee sideslope.

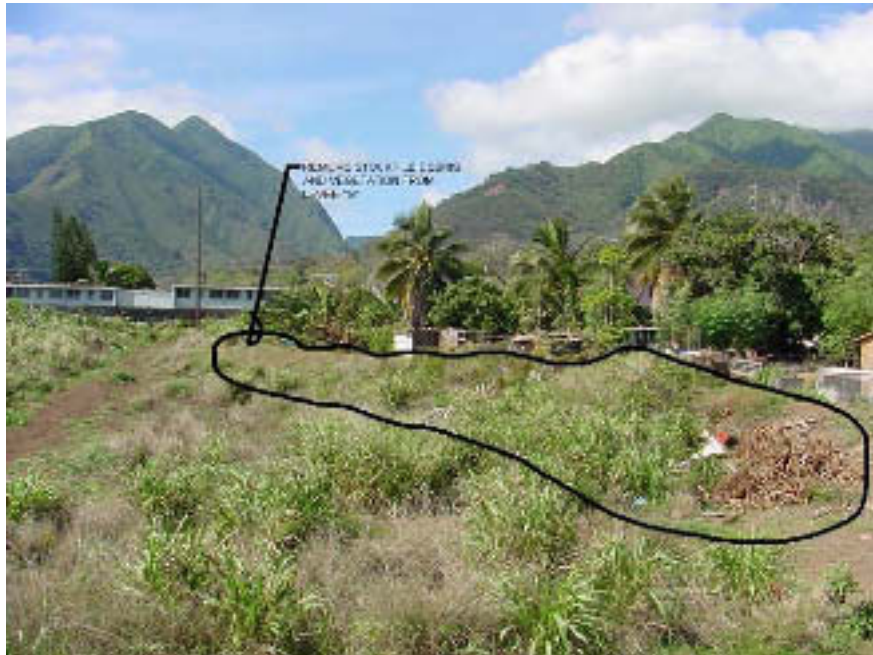
| Station | Location | Description |
|---|---|---|
| 90+00 | Levee G | Remove stockpile debris, vegetation, and fencing encroachments on levee. Beware of dogs. |

q. Sta. 90+00, remove stockpile debris and vegetation.

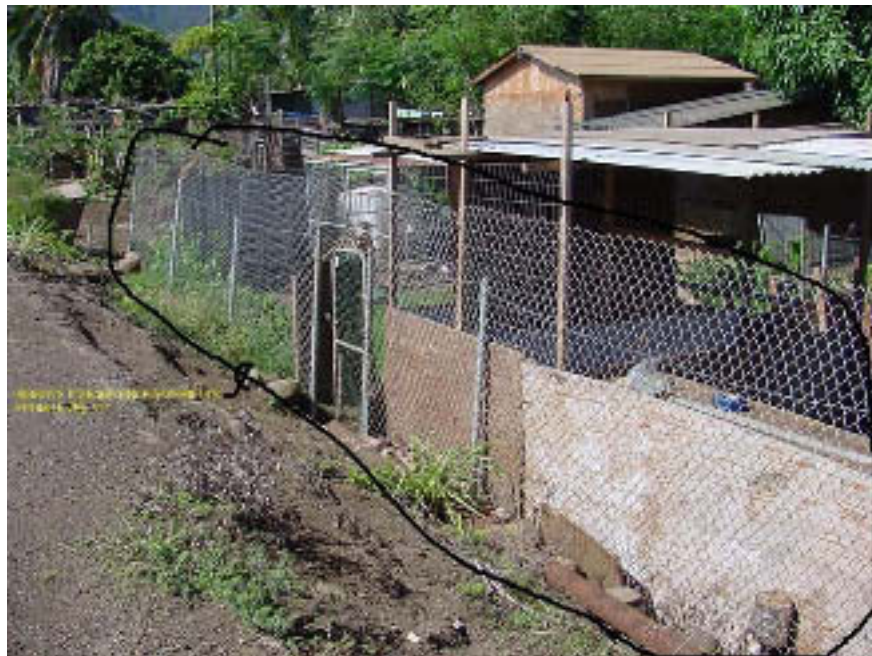
r. Sta. 90+00, remove unauthorized structure (dog fence) from levee sideslope on townside.

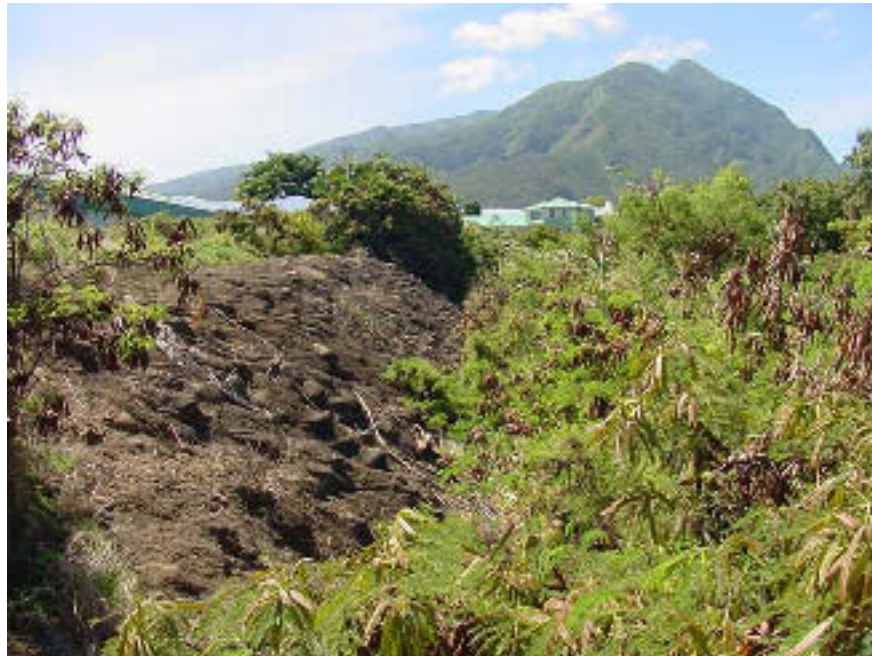
| Station | Location | Description |
|---|---|---|
| 79+36 | RB, Levee E | Vegetation to remain in order to stabilize bank. Continue to monitor levee. |

s. Sta. 79+36, RB, no work required. Vegetation to remain to stabilize sideslope. Continue to monitor levee E.

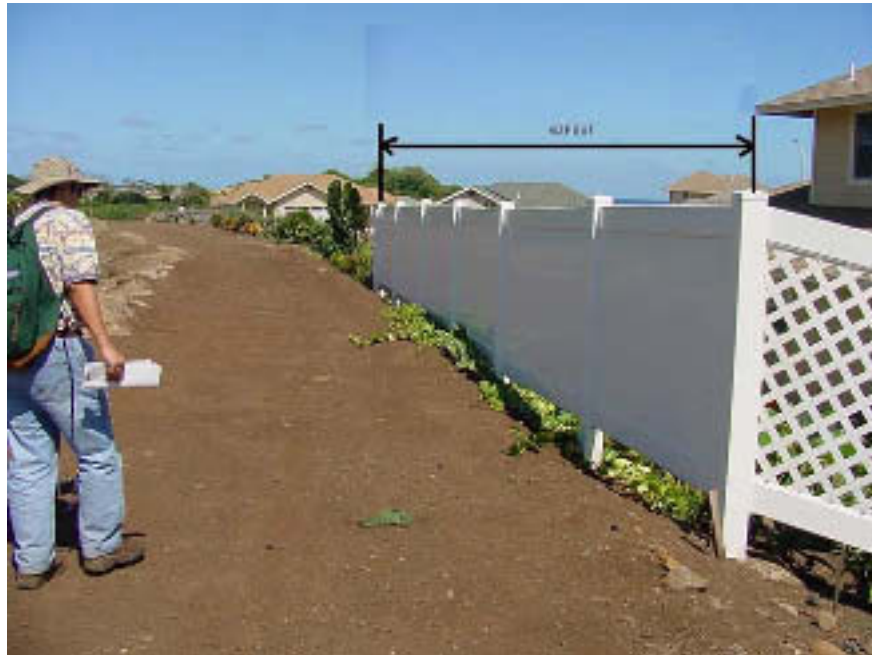
| Station | Location | Description |
|---|---|---|
| 65+25 to 57+00 | RB, Levee C and D, and Revetment X on townside | Verify all encroachments onto levee within these stations. Do the encroachments enter levee easements. |

u. Approximate Sta. 65+25 within Levee "D", 50' long white pvc fence. Verify if fence is an encroachment onto the levee; does fence intrude upon easement. Verify if there are any other encroachments on the levee between station 65+25 and station 57+00.

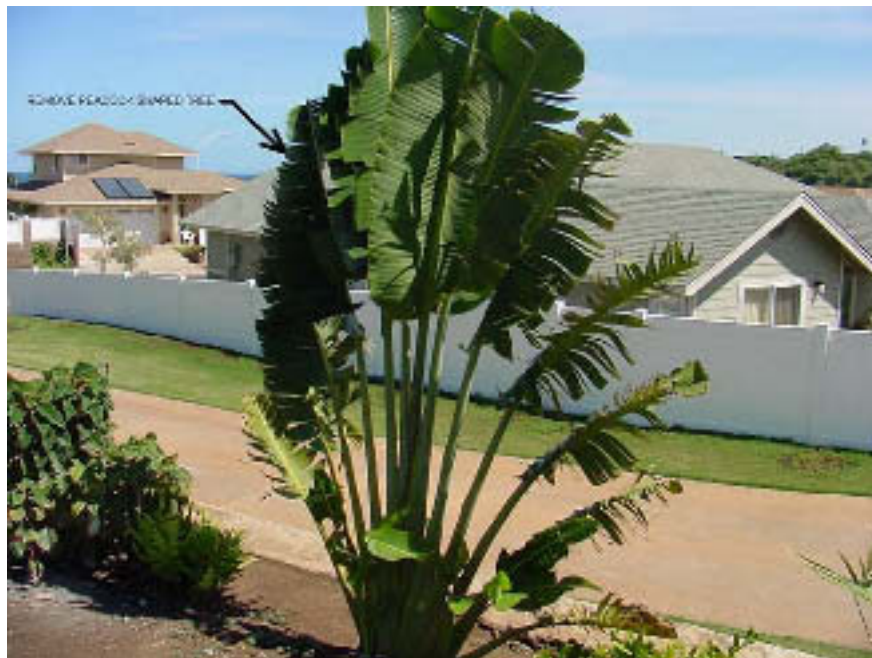
| Station | Location | Description |
|---|---|---|
| 64+70 | RB, between Levee D and C | Remove peacock shaped tree. |

v. Approximate Sta. 64+70 between Levees "C" and "D", remove peacock shaped tree.

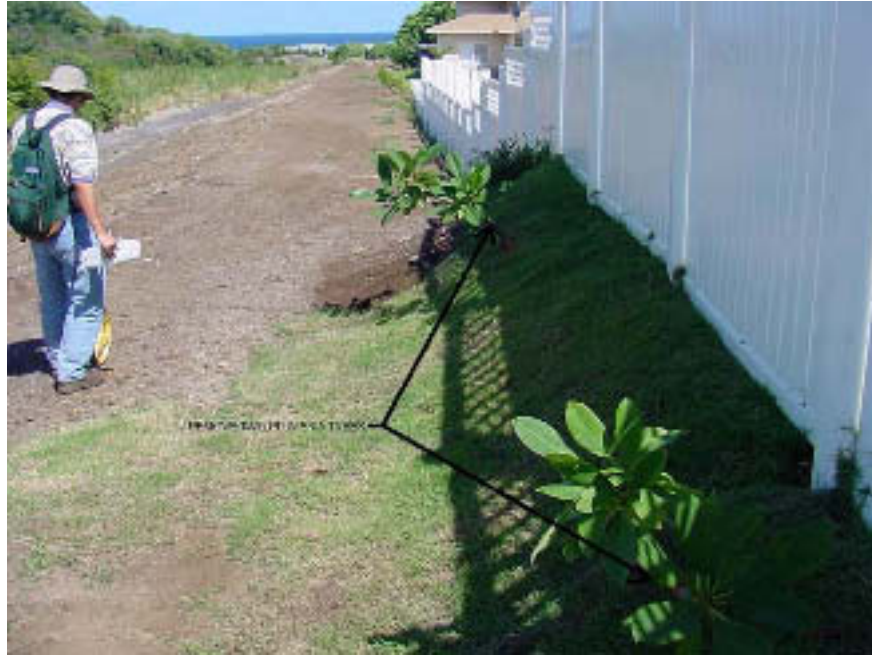
| Station | Location | Description |
|---|---|---|
| 57+50 | RB, Revetment X | Remove two plumeria trees from levee. |

y. Approximate Sta. 57+50 within Revetment "X", remove two (2) plumeria trees.

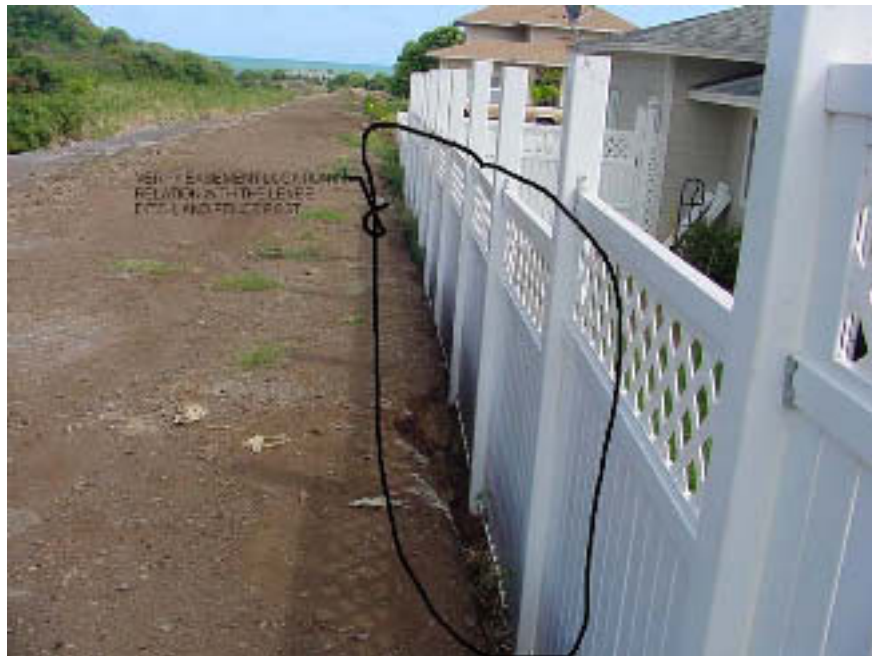
y2. Approximate Sta. 57+00 within Revetment "X", verify easement location in relation to the levee, ditch, and fence post. Take action as required if fence post is within easement.

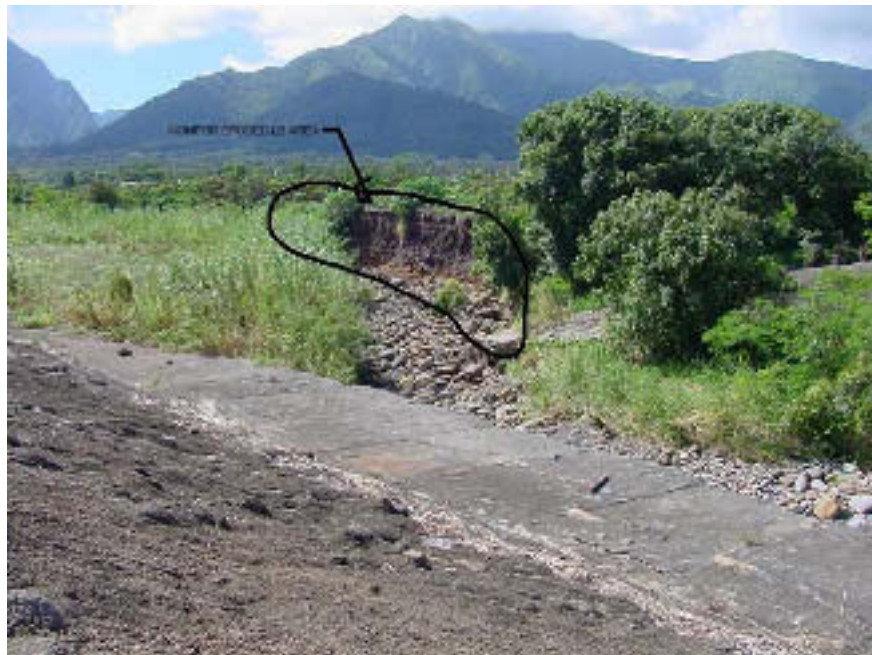
| Station | Location | Description |
|---|---|---|
| 49+00 | LB, Revetment X limits | Monitor eroded area. |

aa. Approximate Sta. 49+00 within Revetment X, monitor eroded area.

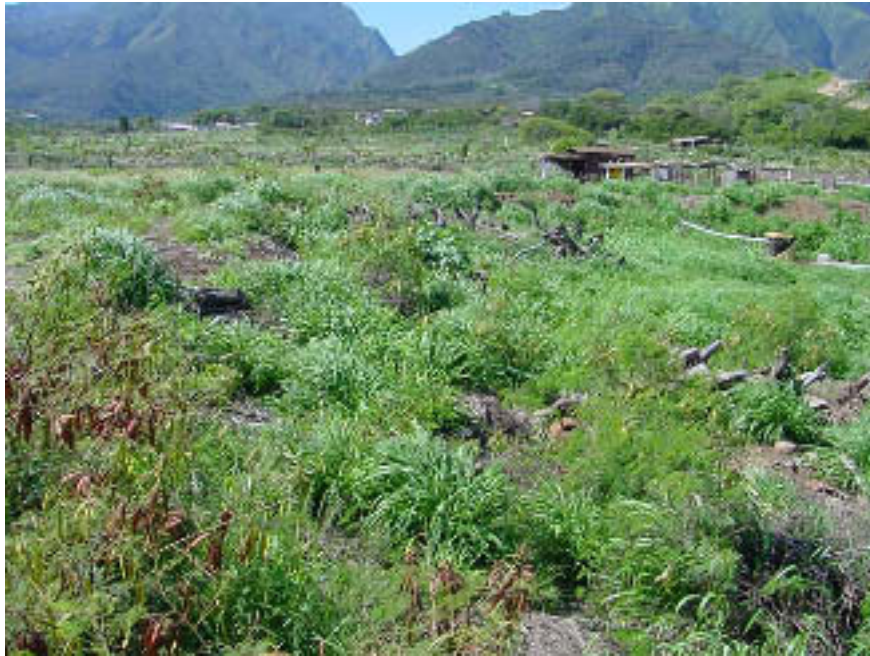
| Station | Location | Description |
|---|---|---|
| 51+40 | Levee F | Remove debris, restore sideslope, and cut vegetation. |

bb. Sta 51+40, remove debris, restore sideslope, and cut vegetation.

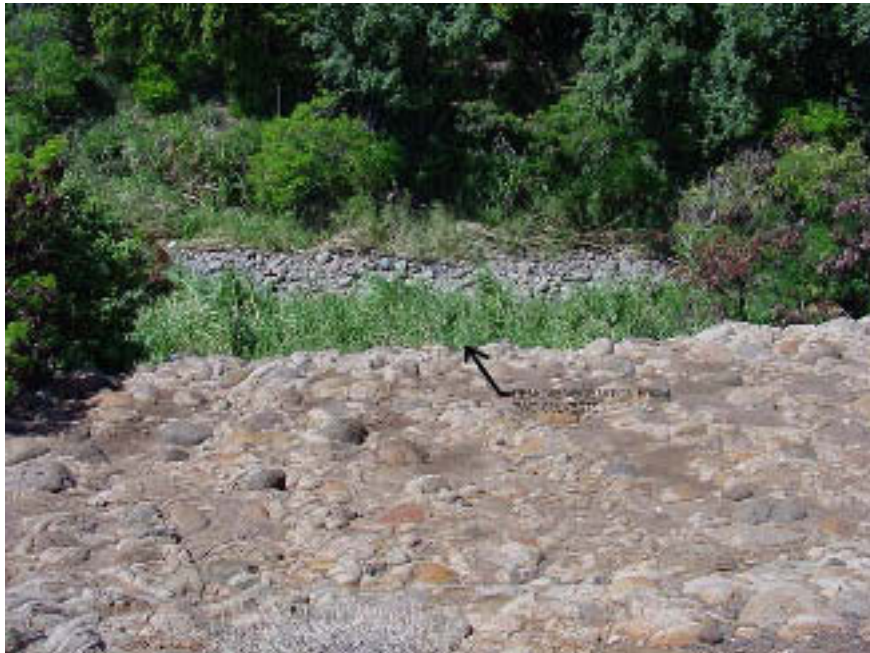
| Station | Location | Description |
|---|---|---|
| 45+00 | RB, Levee B | Remove vegetation from both 54" RCP drain pipes. |

cc. Approximate Sta. 45+00, RB, remove vegetation from two 54" RCP drain lines within levee B referenced from "Iao Parkside" drawings, sheet 11, dated December 4, 1992, Job No. 90044, by Warren S. Unemori Engineering Inc.

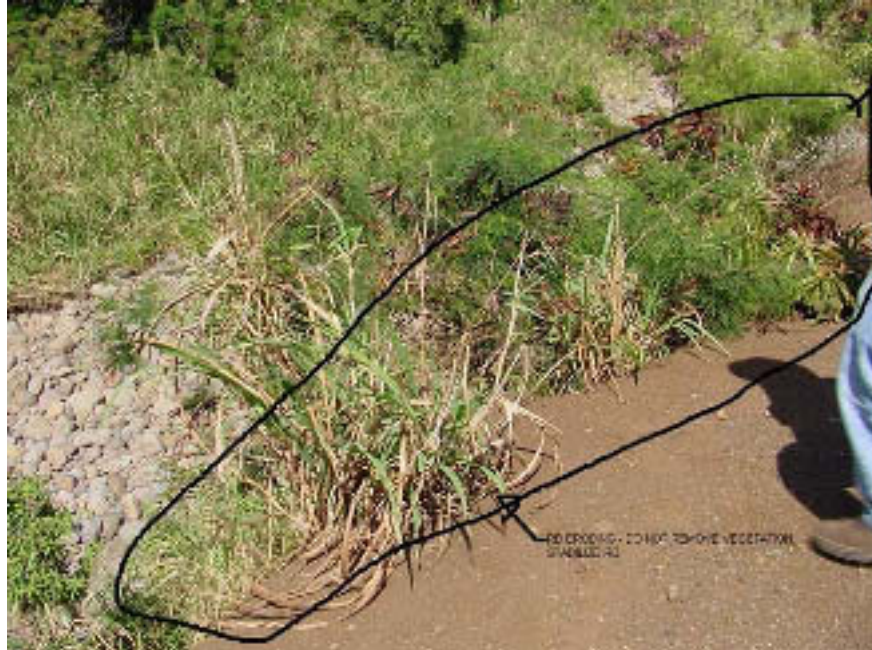
| Station | Location | Description |
|---|---|---|
| 38+50 | RB, between Levee B and A | Repair and stabilize eroded stream sideslope. |

ee. Approximate Sta. 38+50, RB, repair eroded stream bank between levees "A" and "B".

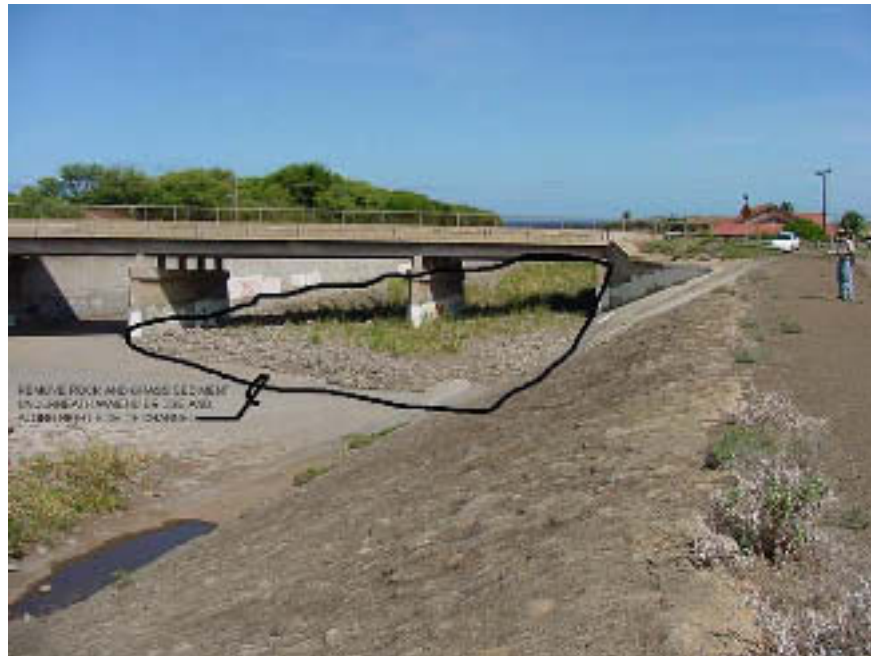
| Station | Location | Description |
|---|---|---|
| 19+65 to 0+00 | Channel under Waiehu Bridge to mouth of stream. | Remove rocks and vegetation. |

ff. Sta. 19+65, RB, remove rocks and vegetation under Waiehu Bridge and beyond.

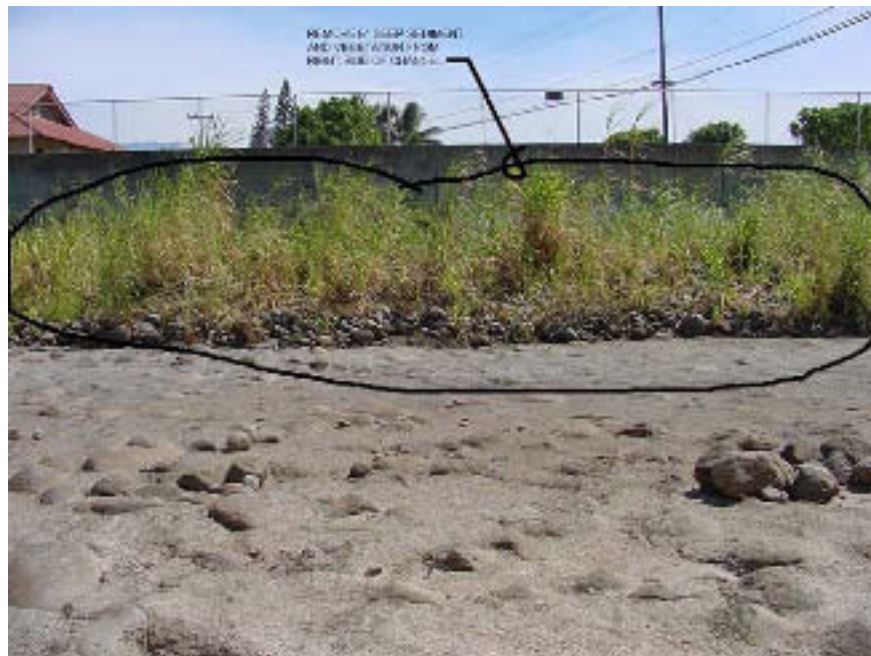
gg. Approximate Sta. 18+50, RB, remove rocks and vegetation from channel bottom.

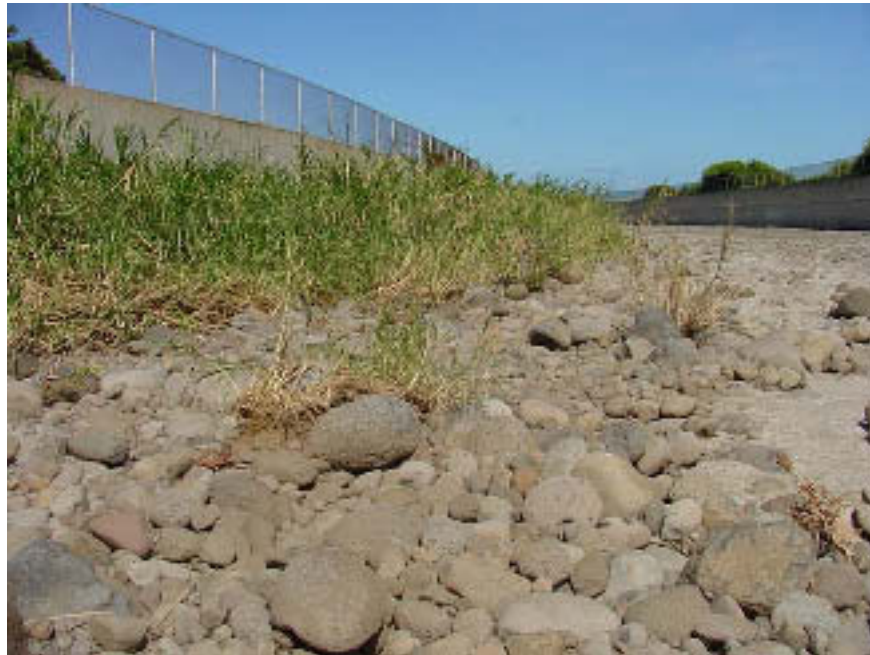
hh. Approximate Sta. 17+50, remove rocks and vegetation from channel bottom.
